# Manhole Inspection Summary

Manhole # S11Y\_\_002MH

Insp Date: **4/7/08 9:29 AM**

**Location** Address: **1201 Bloomfield Ave**

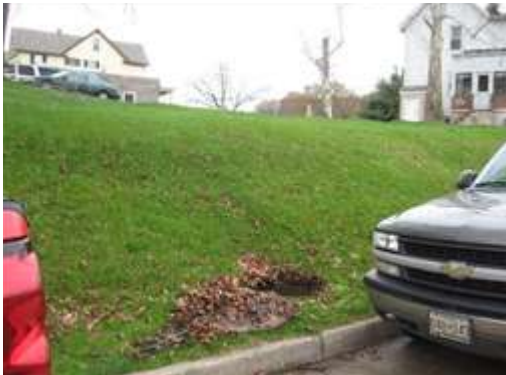
Location View

across from 1201 Bloomfield Ave

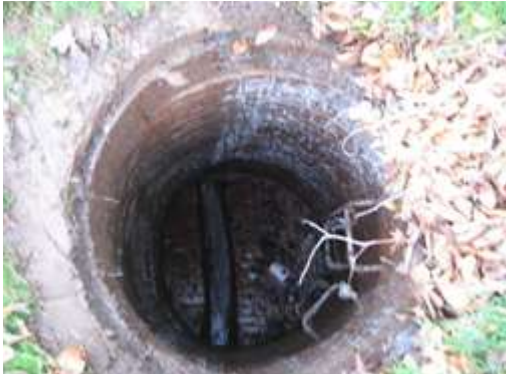
Defect 1

**Steps** Count: **5** Missing: **0** ☒ **Corroded**

corroded steps

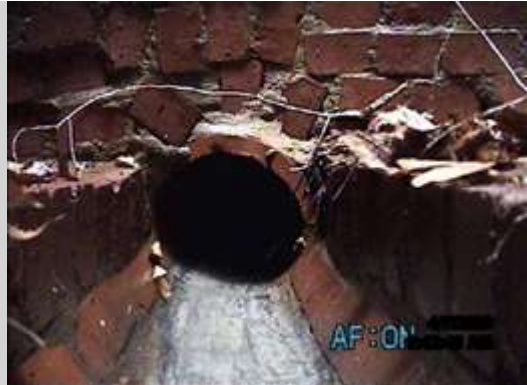
12 O'Clock Outflow

8 in. Circular Gravity Sewer  
Pipe Out @ 12 O'Clock

Pipe Height: **7.2** (in.) Rod and Bar (Angled)  
Pipe Material: **Clay** ☐ Pipe Lined  
Invert Depth: **10.85** (ft.) Flow Characteristics: **Fast**  
Deposits: ☒ None ☐ Mud ☐ Sludge ☐ Debris ☐ Grease  
Silt Depth: **0** (in.) Deposits Extent:  
Infiltration: **None** Pipe Seal Cond: **Sound**

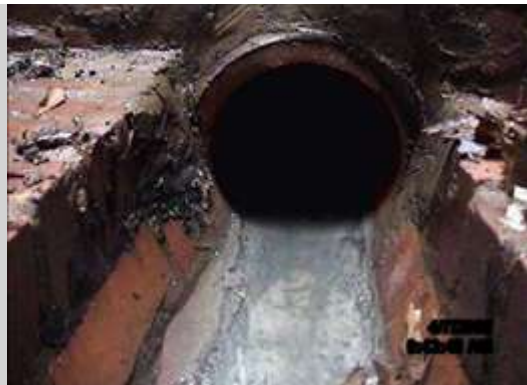
6 O'Clock Inflow

8 in. Circular Gravity Sewer  
Pipe In @ 6 O'Clock

Pipe Height: **8.4** (in.) Rod and Bar (Angled)  
Pipe Material: **Clay** ☐ Pipe Lined  
Invert Depth: **10.47** (ft.) Flow Characteristics: **Fast**  
Deposits: ☒ None ☐ Mud ☐ Sludge ☐ Debris ☐ Grease  
Silt Depth: **0** (in.) Deposits Extent:  
Infiltration: **None** Pipe Seal Cond: **Sound**
